System package 10 Hotfix2

Date: 7. May 2019
Version: 002

MOVI-C system package 10 – Hotfix2

installation information

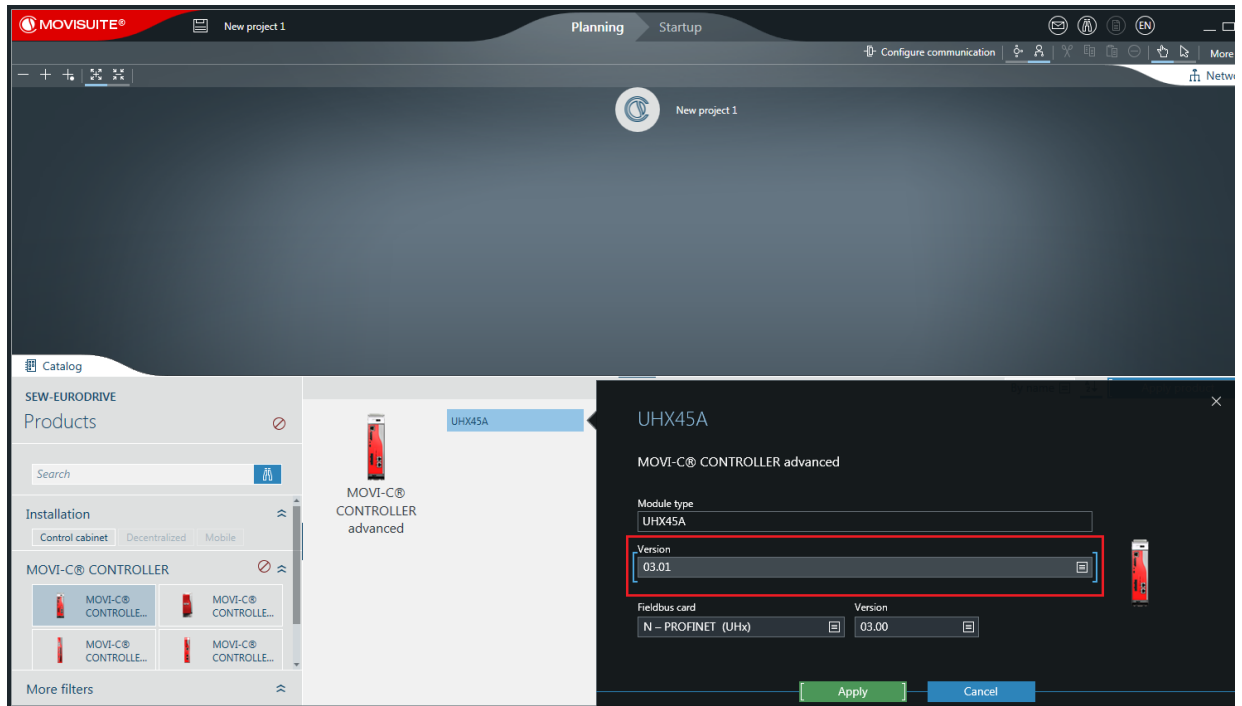
1. After installing Hotfix2 add, in a new MOVISUITE® project, the corresponding controller with firmware version V3.01.

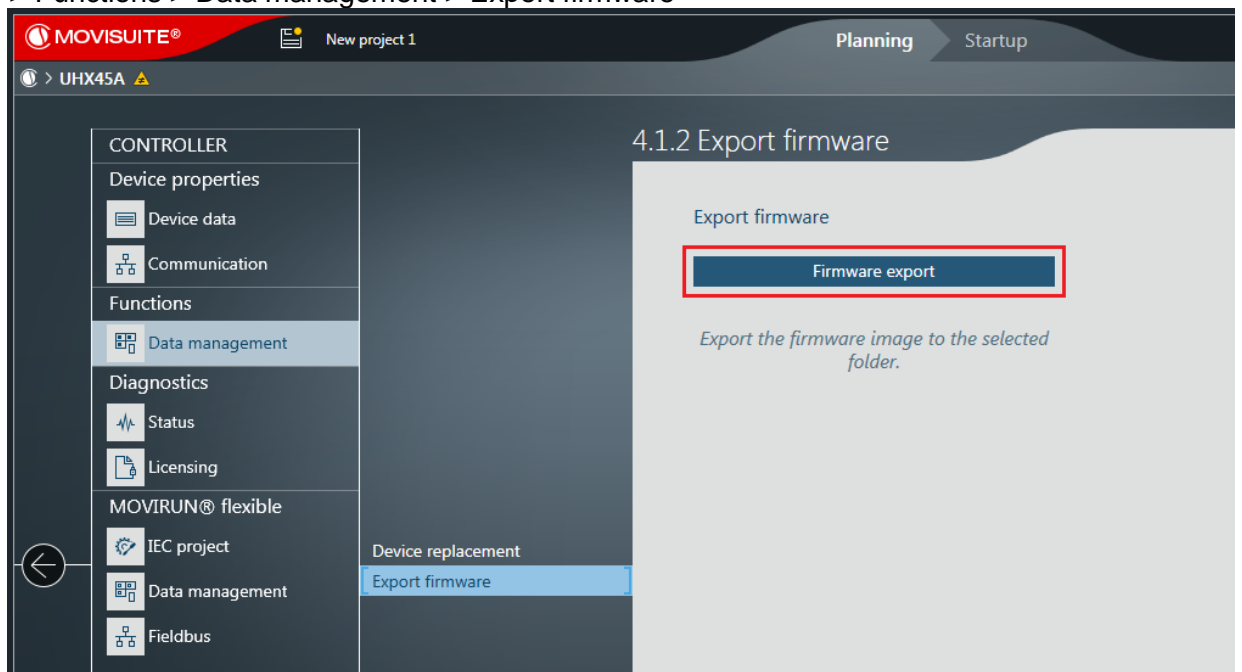
2. Now you can export and unpack the firmware V3.01 in the CONTROLLER configuration area > Functions > Data management > Export firmware

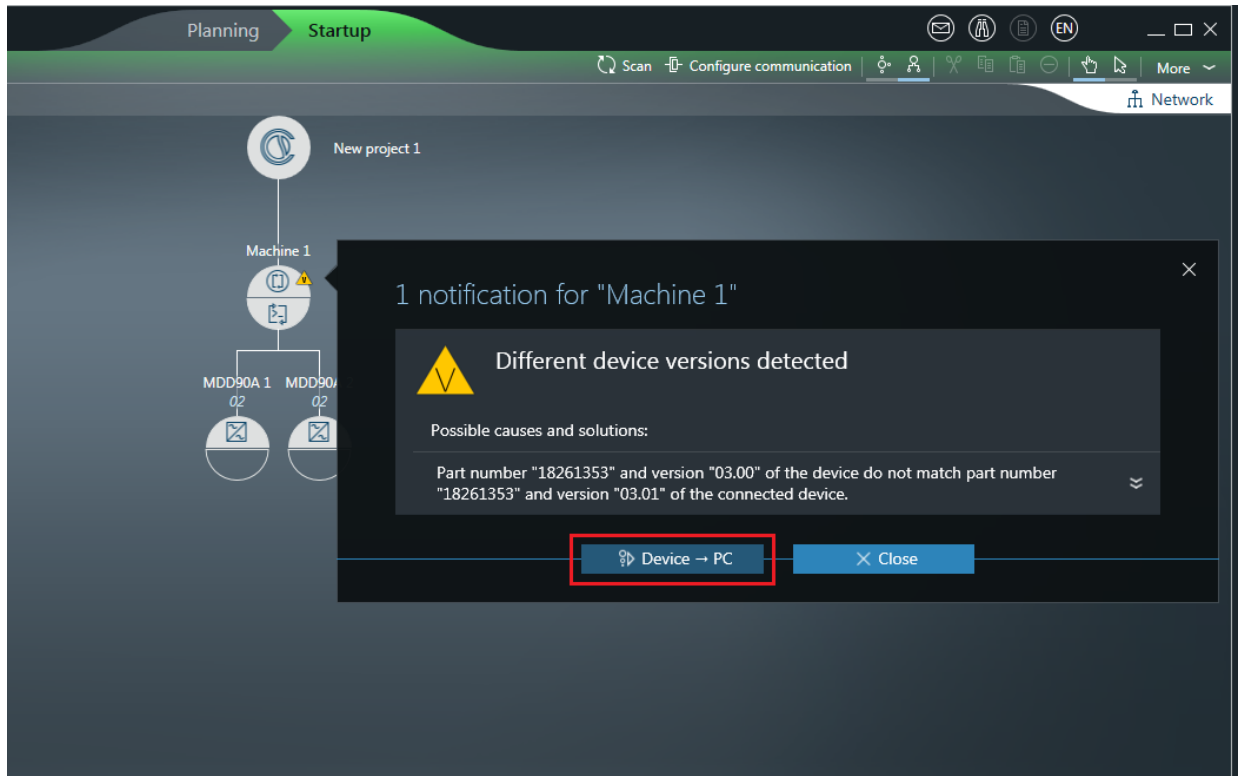
6. Open the associated project in MOVISUITE®. Create an archive as a backup. Then establish a physical connection to the CONTROLLER and switch to the "Startup" mode. A "V" appears on the CONTROLLER. Click on it. The message "Different device versions detected" appears, click on the "Device -> PC" button.

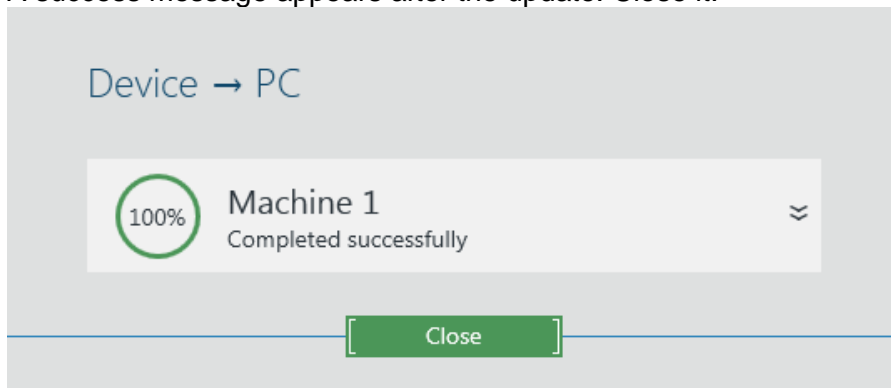
7. A success message appears after the update. Close it.

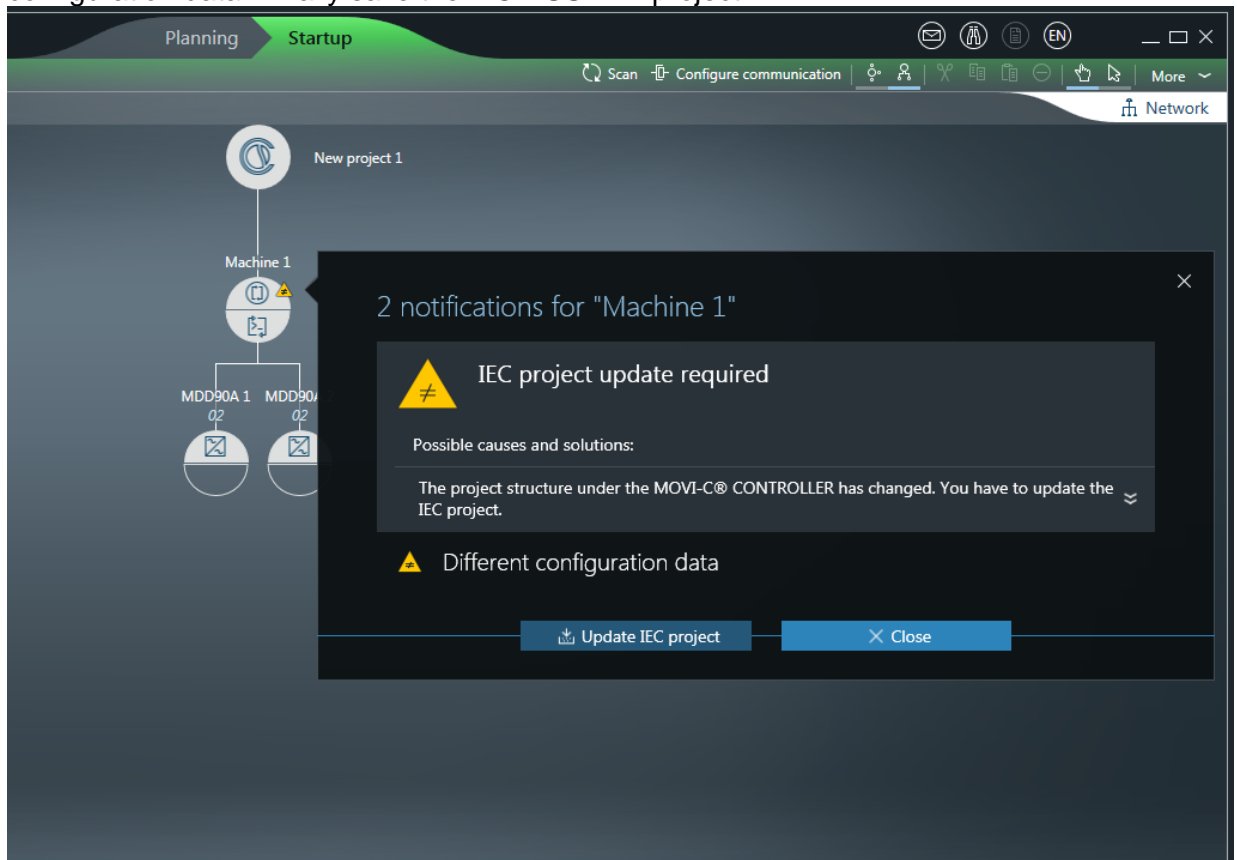
- At the end of the migration, perform an ordinary IEC project update. This will also update the configuration data. Finally save the MOVISUITE® project.
